| <b>Title:</b> AE80F AUTOMATIC TRANSMISSION / TRANSAXLE: COMBINATION SWITCH: INSPECTION; 2016 - 2018 MY LX570 [09/2015 - ] | | |

1. INSPECT INTEGRATION CONTROL AND PANEL ASSEMBLY

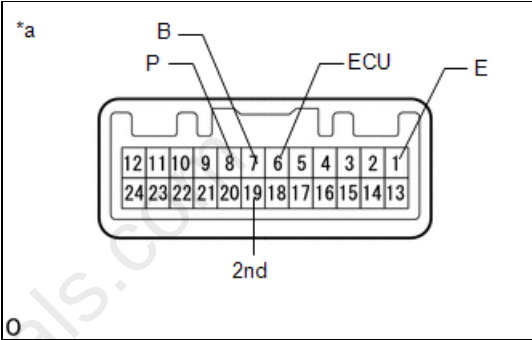
(a) Measure the resistance according to the value(s) in the table below.

| TESTER CONNECTION | SWITCH CONDITION | SPECIFIED CONDITION |
| 8 (P) - 1 (E) | SPORT S or SPORT S+ mode switch turned and held at SPORT S or SPORT S+ position | Below 1 Ω |
| | SPORT S or SPORT S+ mode switch not turned | 10 kΩ or higher |
| 6 (ECU) - 1 (E) | COMF or ECO mode switch turned and held at COMF or ECO position | Below 1 Ω |
| | COMF or ECO mode switch not turned | 10 kΩ or higher |
| 19 (2nd) - 1 (E) | Mode switch (ECT 2nd) on | Below 1 Ω |
| | Mode switch (ECT 2nd) off | 10 kΩ or higher |
| 7 (B) - 1 (E) | NORMAL mode switch pushed and held | Below 1 Ω |
| | NORMAL mode switch not pushed | 10 kΩ or higher |

| *a | Component without harness connected<br>(Integration Control and Panel Assembly) |

If the result is not as specified, replace the integration control and panel assembly.
