| <b>Title:</b> AE80F AUTOMATIC TRANSMISSION / TRANSAXLE: PARK / NEUTRAL POSITION SWITCH: INSPECTION; 2016 - 2018 MY LX570 [09/2015 - ] | | |

### 1. INSPECT PARK/NEUTRAL POSITION SWITCH ASSEMBLY

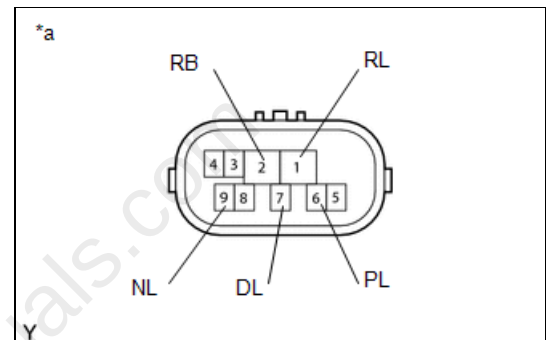
(a) Measure the resistance according to the value(s) in the table below.

| *a | Component without harness connected<br>(Park/Neutral Position Switch Assembly) |

Standard Resistance:

| TESTER CONNECTION | CONDITION | SPECIFIED CONDITION |
| 6 (IG) - 4 (C) | Shift lever in D and S | Below 1 $\Omega$ |
| 6 (IG) - 5 (A) | Shift lever in P and R | Below 1 $\Omega$ |
| 6 (IG) - 7 (PA) | Shift lever in P and N | Below 1 $\Omega$ |
| 6 (IG) - 9 (B) | Shift lever in R, N, D and S | Below 1 $\Omega$ |
| 1 (RB) - 2 (RL) | Shift lever in R | Below 1 $\Omega$ |
| 3 (B) - 4 (C) | Shift lever in P and N | Below 1 $\Omega$ |
| 6 (IG) - 4 (C) | Shift lever not in D and S | 10 k $\Omega$ or higher |
| 6 (IG) - 5 (A) | Shift lever not in P and R | 10 k $\Omega$ or higher |
| 6 (IG) - 7 (PA) | Shift lever not in P and N | 10 k $\Omega$ or higher |
| 6 (IG) - 9 (B) | Shift lever not in R, N, D and S | 10 k $\Omega$ or higher |
| 1 (RB) - 2 (RL) | Shift lever not in R | 10 k $\Omega$ or higher |
| 3 (B) - 4 (C) | Shift lever not in P and N | 10 k $\Omega$ or higher |

If the result is not as specified, replace the park/neutral position switch assembly.
