| <b>Title:</b> AE80F AUTOMATIC TRANSMISSION / TRANSAXLE: PARK / NEUTRAL POSITION SWITCH: REMOVAL; 2016 - 2018 MY LX570 [09/2015 - ] | | |

## REMOVAL

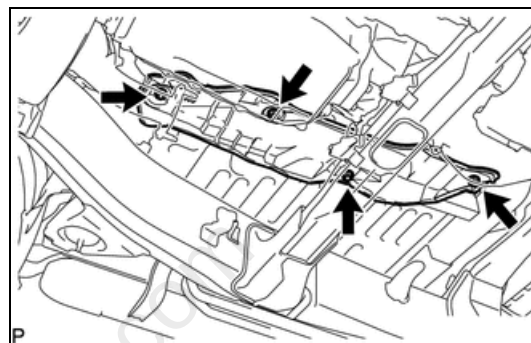
(a) Remove the 4 nuts and No. 3 front floor heat insulator.

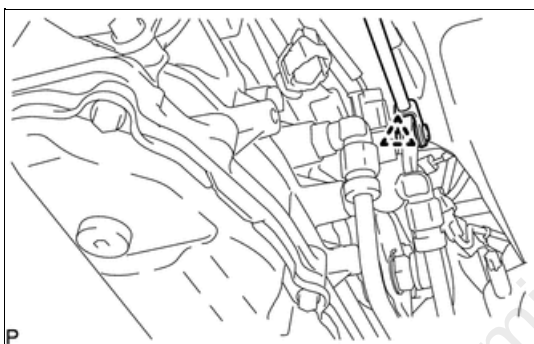
(a) Remove the clip and pin, and disconnect the floor shift gear shifting rod sub-assembly from the transmission control shaft lever.

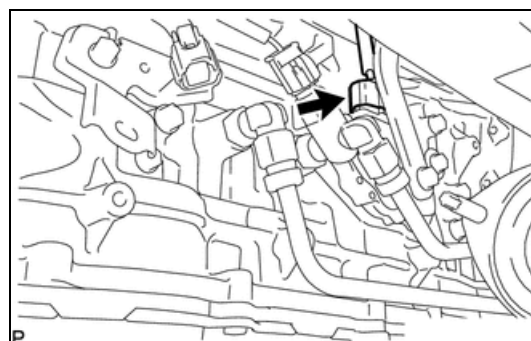
(a) Disconnect the switch connector.

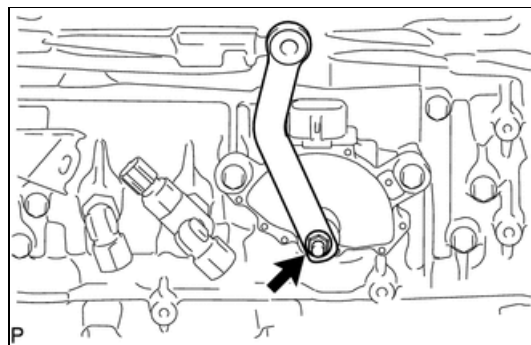
(b) Remove the nut, spring washer and transmission control shaft lever.

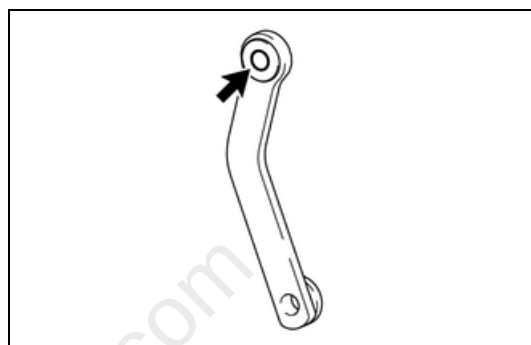
(c) Remove the bush from the transmission control shaft lever.

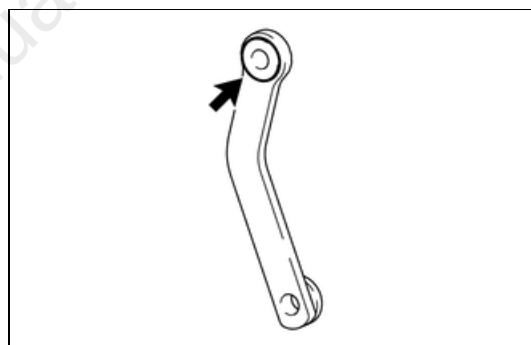
(d) Remove the No. 1 floor shift bush from the transmission control shaft lever.

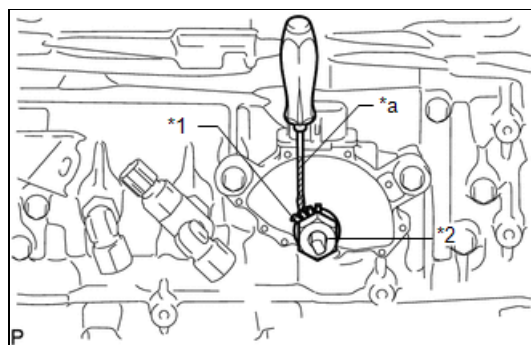
(e) Using a screwdriver, bend the tabs of the lock washer.

Tape the screwdriver tip before use.

| *1 | Lock Washer |
| *2 | Lock Nut |
| *a | Protective Tape |

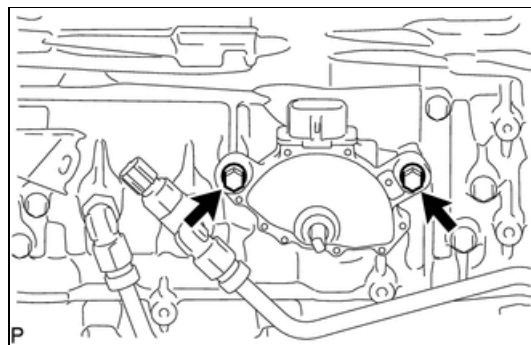
(f) Remove the lock nut and lock washer.

(g) Remove the 2 bolts and park/neutral position switch assembly.

Make sure that the manual valve lever shaft has not been rotated prior to installing the park/neutral position switch assembly as the detent spring may become detached from the manual valve lever shaft.
