| <b>Title:</b> AE80F AUTOMATIC TRANSMISSION / TRANSAXLE: SHIFT LEVER: DISASSEMBLY; 2016 - 2018 MY LX570 [09/2015 - ] | | |

## **DISASSEMBLY**

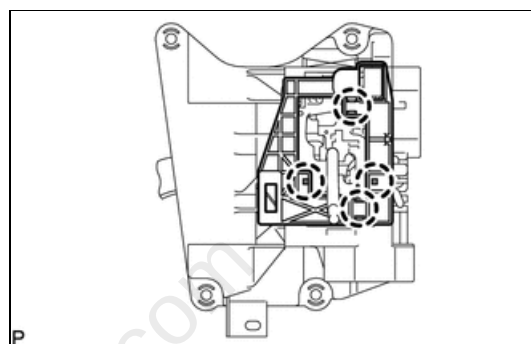
- (a) Detach the 4 claws and remove the lower position indicator housing.

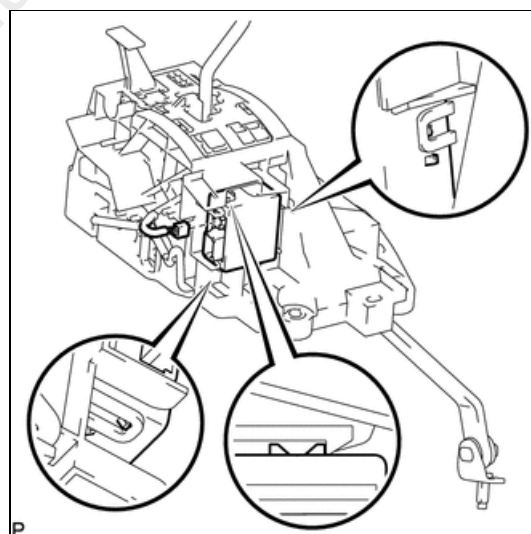
- (a) Disconnect the shift lock solenoid connector.

- (b) Detach the 3 claws and remove the shift lock control ECU sub-assembly from the lower shift lever assembly.
