| <b>Title:</b> AE80F AUTOMATIC TRANSMISSION / TRANSAXLE: SHIFT LEVER: REMOVAL; 2016 - 2018 MY LX570 [09/2015 - ] | | |

# REMOVAL

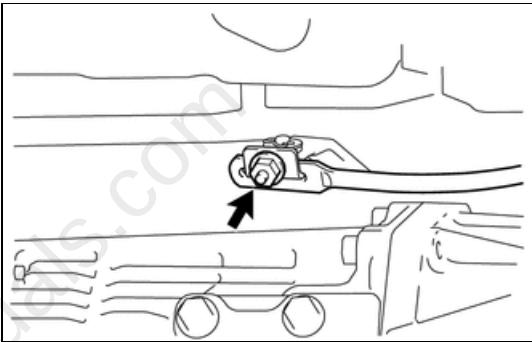
### 3. DISCONNECT FLOOR SHIFT GEAR SHIFTING ROD SUB-ASSEMBLY

- (a) Move the shift lever to N.
- (b) Remove the nut and disconnect the floor shift gear shifting rod sub-assembly from the transmission floor shift assembly.

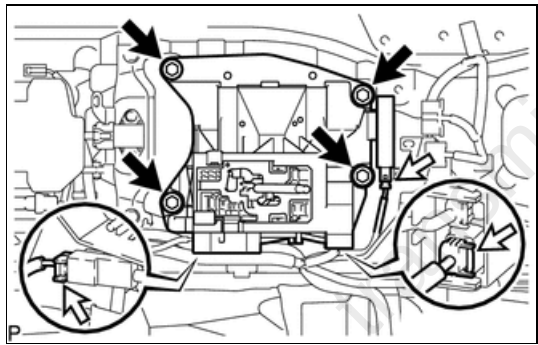
### 4. REMOVE TRANSMISSION FLOOR SHIFT ASSEMBLY

- (a) Disconnect the 3 connectors.

| | Bolt |
| | Connector |

- (b) Remove the 4 bolts and transmission floor shift assembly.
