| <b>Title:</b> AE80F AUTOMATIC TRANSMISSION / TRANSAXLE: SHIFT PADDLE SWITCH: REMOVAL; 2016 - 2018 MY LX570 [09/2015 - ] | | |

## REMOVAL

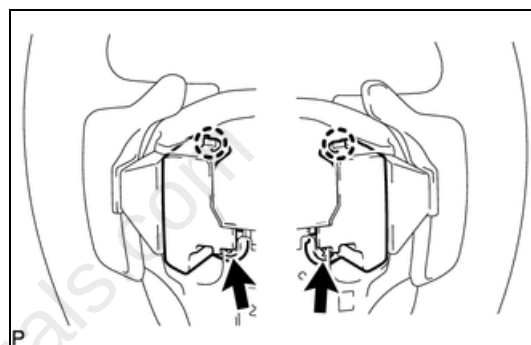
(a) Remove the 2 screws.

(b) Detach the 2 claws and remove the 2 No. 1 steering wheel boss cover lower.

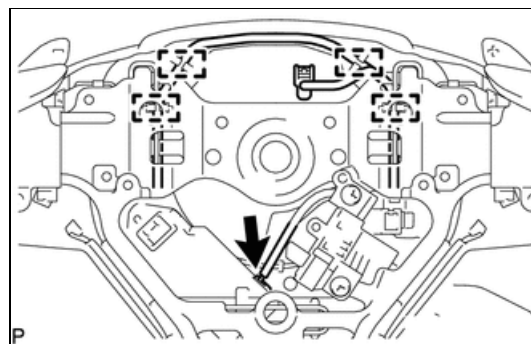
(a) Disconnect the connector and 4 clamps.

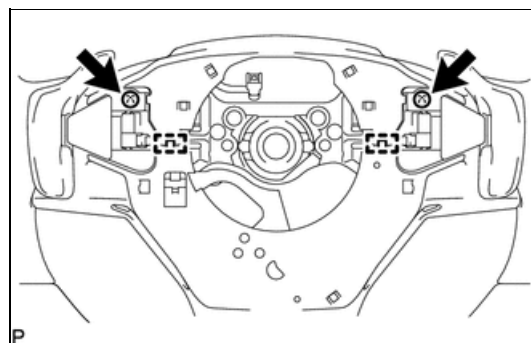
(b) Disconnect the 2 guides and remove the 2 screws.

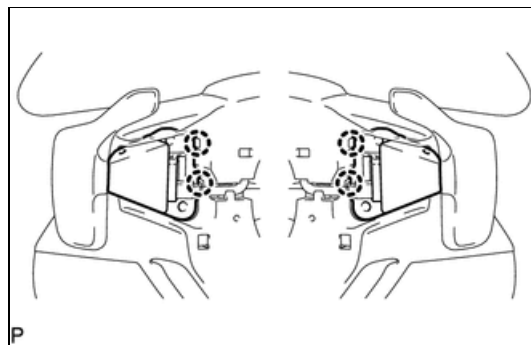
- (c) Detach the 4 claws and remove the 2 transmission shift switch assemblies with No. 1 switch wire from the steering wheel assembly.
