| <b>Title:</b> AE80F AUTOMATIC TRANSMISSION / TRANSAXLE: TCM: REMOVAL; 2016 - 2018 MY LX570 [09/2015 - ] | | |

## REMOVAL

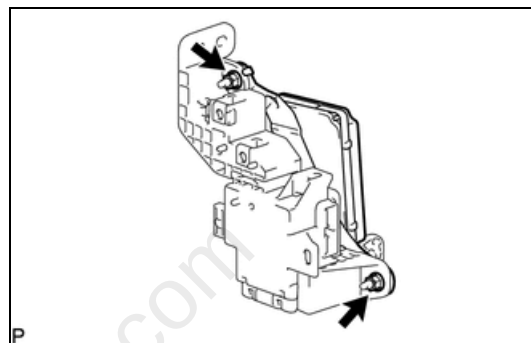
(a) Remove the 2 nuts and TCM from the cowl side junction block RH.
