| <b>Title:</b> AE80F AUTOMATIC TRANSMISSION / TRANSAXLE: TRANSMISSION WIRE: REMOVAL; 2016 - 2018 MY LX570 [09/2015 - ] | | |

#### 2. REMOVE TRANSMISSION WIRE

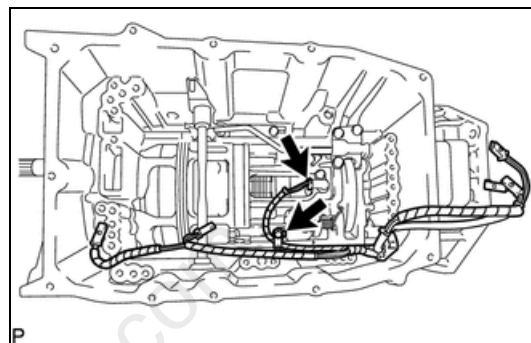
- (a) Disconnect the connector from the transmission revolution sensor (SP2).

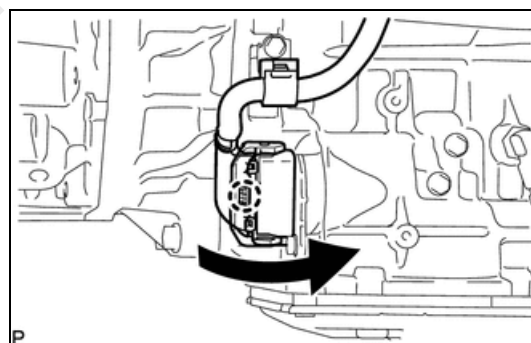
- (b) Remove the bolt and wire harness clamp.

- (c) Disconnect the transmission wire connector.

Detach the claw, pull the lever, and then disconnect the transmission wire connector.

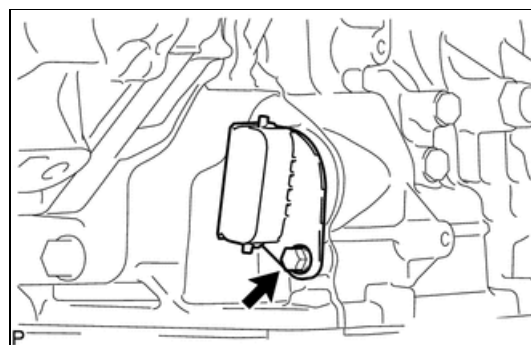
- (d) Remove the bolt and pull out the transmission wire.
