| <b>Title:</b> AXLE AND DIFFERENTIAL: FRONT AXLE HUB: DISASSEMBLY; 2016 - 2018 MY LX570 [09/2015 - ] | | |

## DISASSEMBLY

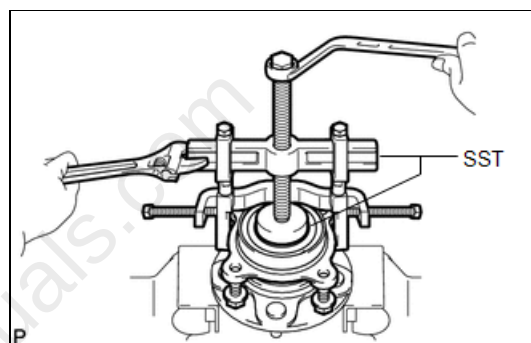
(b) Using SST, remove the bearing.

**SST: 09950-40011**

**SST: 09950-60010**

09951-00550

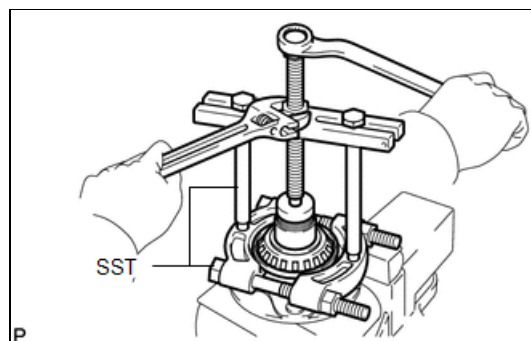
(c) If part of the bearing remains in the front axle hub, use SST to remove it.

**SST: 09950-00020**

**SST: 09950-00030**

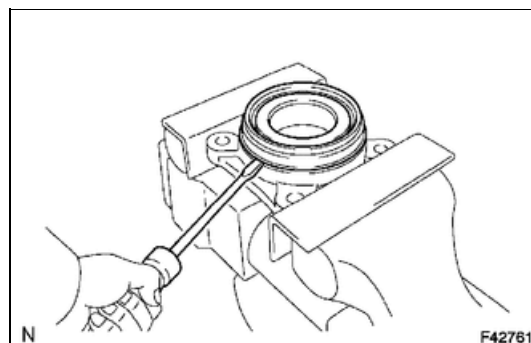
F42761

(a) Using a screwdriver, pry off the oil seal.
