| <b>Title:</b> AXLE AND DIFFERENTIAL: REAR AXLE SHAFT: INSPECTION; 2016 - 2018 MY LX570 [09/2015 - ] | | |

### 1. INSPECT REAR AXLE SHAFT LH

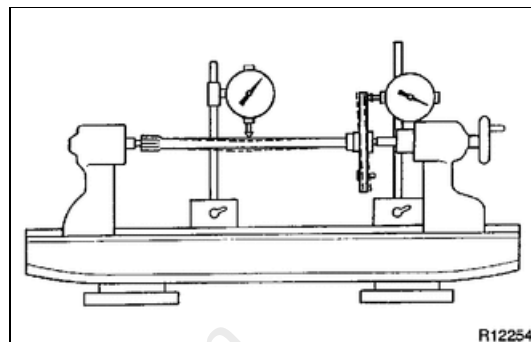
- (a) Using a dial indicator, measure the rear axle shaft runout and flange runout.

Maximum runout:

**Shaft runout**

1.50 mm (0.0591 in.)

**Flange runout**

0.05 mm (0.00197 in.)

If the rear axle shaft or flange is damaged or worn, or if the runout is more than the maximum, replace the rear axle shaft.
