| <b>Title:</b> DRIVE SHAFT / PROPELLER SHAFT: FRONT DRIVE SHAFT ASSEMBLY: INSPECTION; 2016 - 2018 MY LX570 [09/2015 -     ] | | |

### 1. INSPECT FRONT DRIVE SHAFT ASSEMBLY

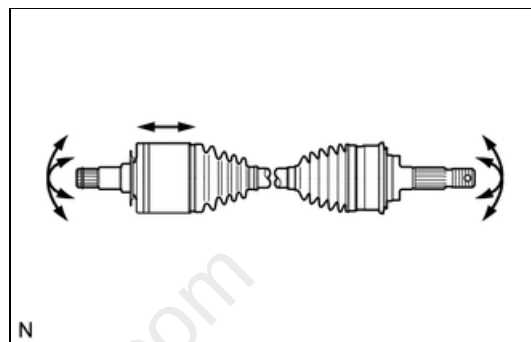
Move the drive shaft while keeping it level.

- (a) Check if there is excessive play in the outboard joint.

- (b) Check if the inboard joint shaft slides smoothly in the thrust direction.  
(c) Check if there is excessive play in the radial direction of the inboard joint shaft.  
(d) Check the boots for damage.

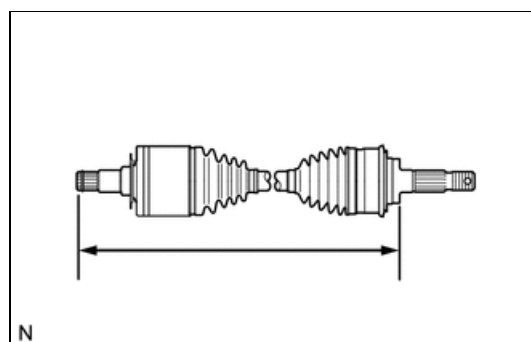
- (e) Check that the 2 boots are not stretched or contracted when the drive shaft is at standard length.

Standard drive shaft length:

583 mm (1.91 ft.)

If the boots are stretched or contracted, correct them.
