| <b>Title:</b> DRIVE SHAFT / PROPELLER SHAFT: PROPELLER SHAFT ASSEMBLY: INSPECTION; 2016 - 2018 MY LX570 [09/2015 - ] | | |

#### 1. INSPECT REAR PROPELLER SHAFT ASSEMBLY

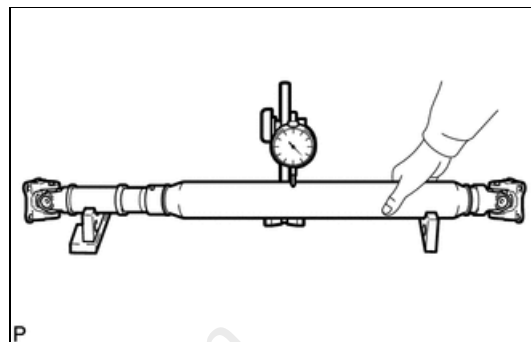
- (a) Using a dial indicator, measure the propeller shaft runout.

Maximum runout:

0.8 mm (0.0315 in.)

If the shaft runout is more than the maximum, replace the shaft.

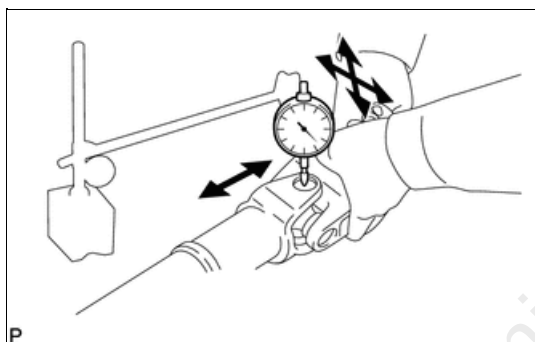
Be careful not to grip the propeller shaft tube too tightly in a vise as this will cause deformation.

- (a) Check the spider bearings for wear or damage.  
 (b) Check the axial play of each spider bearing by turning the yoke while holding the shaft tightly.

Maximum bearing axial play:

0 mm (0 in.)

If the axial play is more than the maximum, replace the spider bearing.

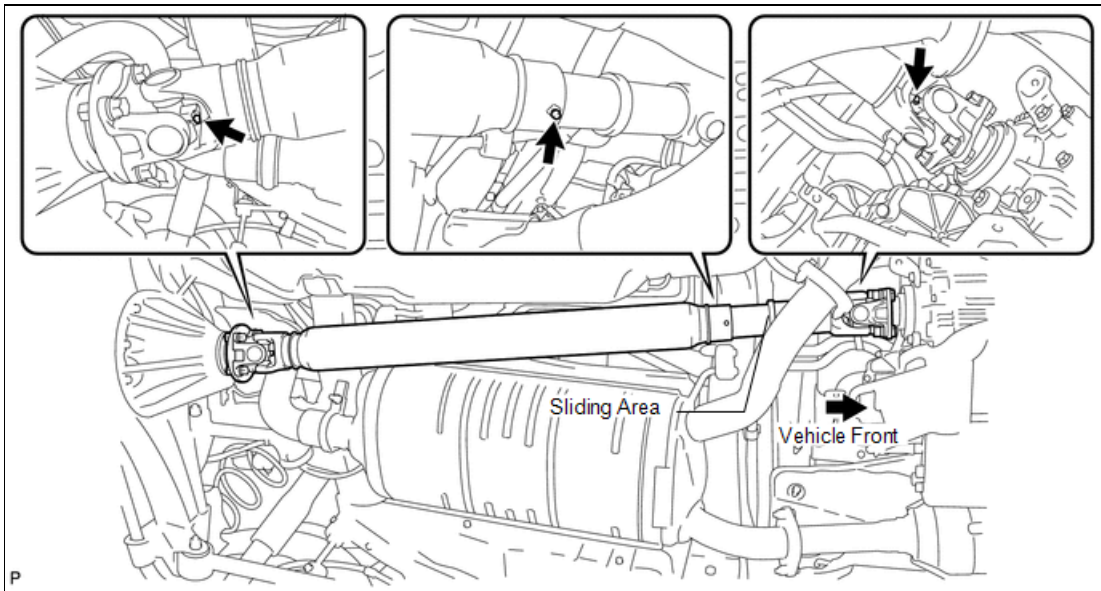
- (a) Fill each of the grease fitting holes of the propeller shaft with MP grease.

Stop filling the grease fitting hole on the middle portion of the propeller shaft once the sliding portion starts extending.
