| Title: JF2A TRANSFER / 4WD / AWD: 4WD CONTROL ECU: REMOVAL; 2016 - 2018 MY LX570 [09/2015 - ] | | |

## REMOVAL

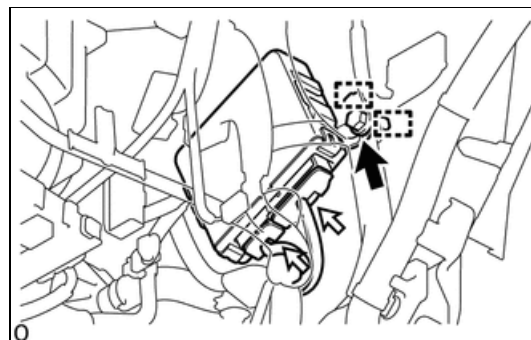
#### 12. REMOVE 4 WHEEL DRIVE CONTROL ECU

(a) Remove the bolt.

(b) Detach the 2 guides and disconnect the 4 wheel drive control ECU.

(c) Disconnect the 2 connectors from the 4 wheel drive control ECU.
