| <b>Title:</b> AB60F AUTOMATIC TRANSMISSION / TRANSAXLE: TORQUE CONVERTER CLUTCH AND DRIVE PLATE: INSPECTION; 2015 MY LX570 [08/2014 - ] | | |

## INSPECTION

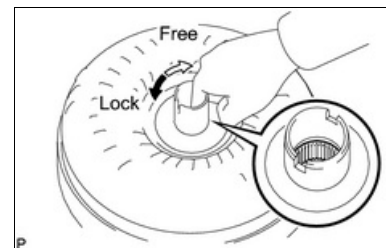
(a) Inspect the 1-way clutch.

- (1) Press on the serrations of the starter with a finger and rotate it. Check that it rotates smoothly when turned clockwise and locks when turned counterclockwise.

If necessary, clean the converter and recheck the 1-way clutch.

Replace the converter if the 1-way clutch still fails the check.

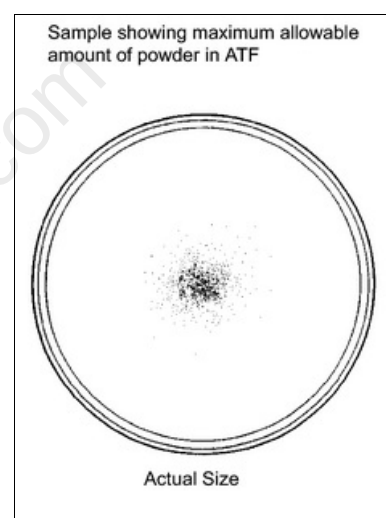
- During the stall test or when the shift lever is in N, metallic sounds are not emitted from the torque converter clutch.
- The 1-way clutch turns in one direction and locks in the other direction.
- The amount of powder in the ATF is not more than the sample shown in the illustration.

The sample illustration shows approximately 0.25 liters (0.26 US qts, 0.22 Imp. qts) of ATF taken from a removed torque converter clutch.

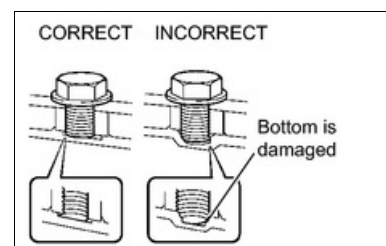
(d) Prevent deformation of the torque converter clutch and damage to the oil pump gear.

- (1) When any marks due to interference are found on the end of the bolt for the torque converter clutch and on the bottom of the bolt hole, replace the bolt and torque converter clutch.
- (2) All of the bolts should be the same length.
- (3) Make sure no spring washers are missing.

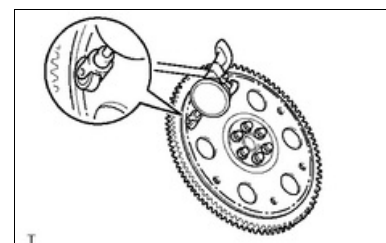
### 2. INSPECT RUNOUT OF DRIVE PLATE AND RING GEAR

(a) Set up a dial indicator and measure the drive plate runout.

Maximum runout:

0.20 mm (0.00787 in.)

If the runout is more than the maximum or if the ring gear is damaged, replace the drive plate [INFO](#).

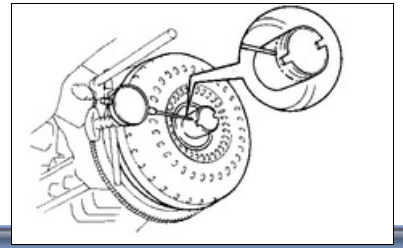
### 3. INSPECT RUNOUT OF TORQUE CONVERTER CLUTCH ASSEMBLY

(a) Temporarily mount the torque converter clutch to the drive plate. Set up a dial indicator and measure the torque converter clutch runout.

Maximum runout:

0.30 mm (0.0118 in.)

If the runout is more than the maximum, try to correct it by changing the installation direction of the torque converter clutch. If the runout cannot be corrected, replace the torque converter clutch.

Mark the position of the torque converter clutch so that it can be installed correctly later.
