# 2013 Chevrolet Colorado

Front Output Shaft Cleaning and Inspection

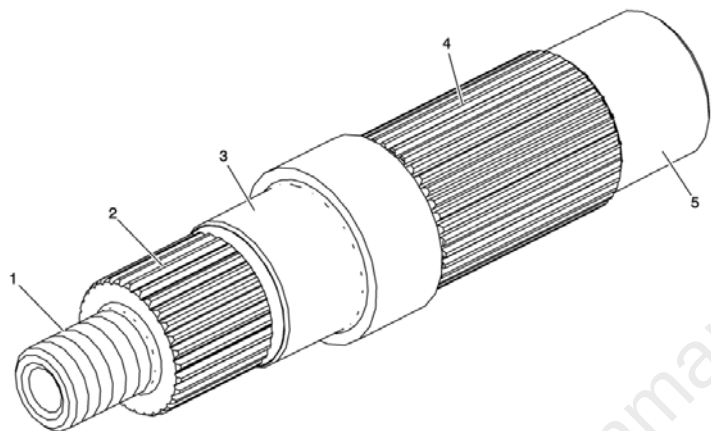
- Inspect all components or sub-components and perform any repair procedure necessary to fix the damage. If the damage cannot be repaired, replace the component or sub-component as indicated.
- Clean all components in cleaning solvent and air dry.

| 1 | Transfer Case Front Output Shaft Flange Nut Threads<br><b>Note:</b> Inspect for excessive wear, or damage. |
| 2 | Transfer Case Front Output Shaft Flange Engagement Splines<br><b>Note:</b> Witness marks at the location of the front output shaft flange is normal. |
| 3 | Transfer Case Front Output Shaft Front Bearing Surface<br><b>Note:</b> Inspect for excessive wear, damage, or if the bearing has spun on the shaft. |
| 4 | Transfer Case Front Output Shaft Driven Sprocket Engagement Splines<br><b>Note:</b> Witness marks at the location of the front output shaft driven sprocket is normal. |
| 5 | Transfer Case Front Output Shaft Rear Bearing Surface<br><b>Note:</b> Inspect for excessive wear, damage, or if the bearing has spun on the shaft. |
