PUBLISHED: 04-OCT-2019  
2020.0 DEFENDER (LE), 311-01

AUTOMATIC TRANSMISSION

# DIAGNOSTICS - VEHICLES WITH: 8HP45 8-SPEED AUTOMATIC TRANSMISSION AWD (G2391365)

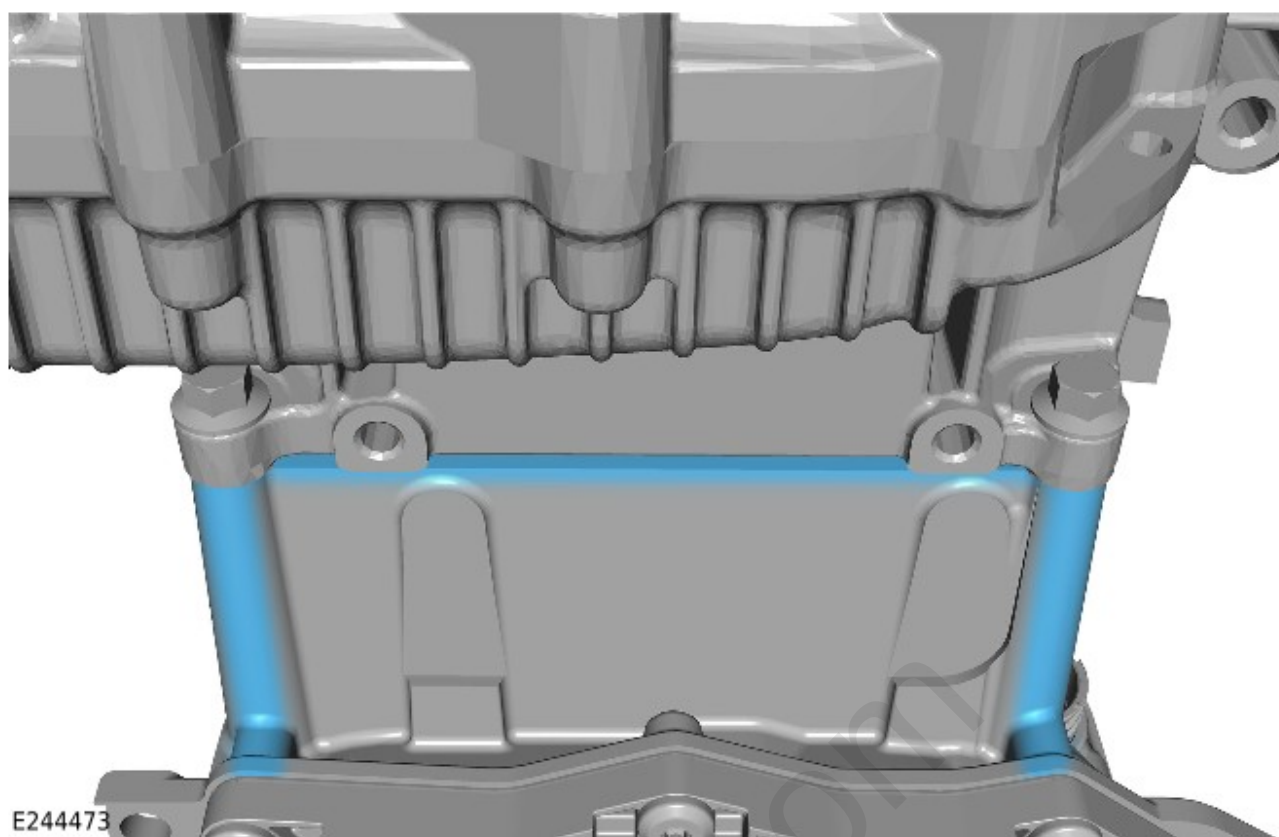
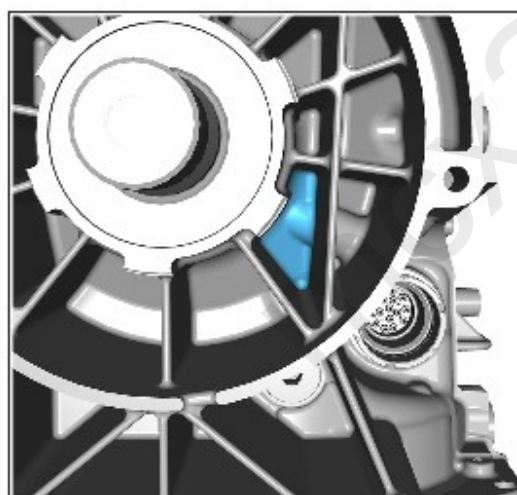
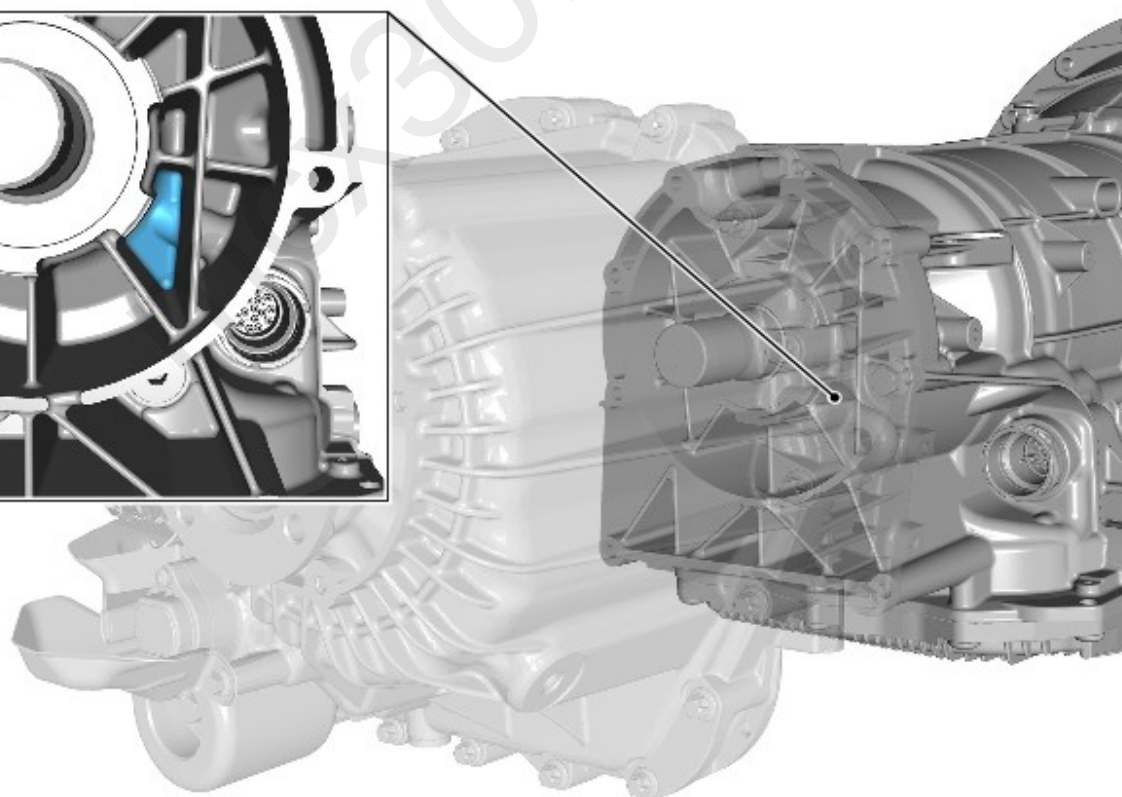
If there are any signs of oil leaks between the automatic transmission and the transfer case, this may be due to internal porosity of the automatic transmission case.

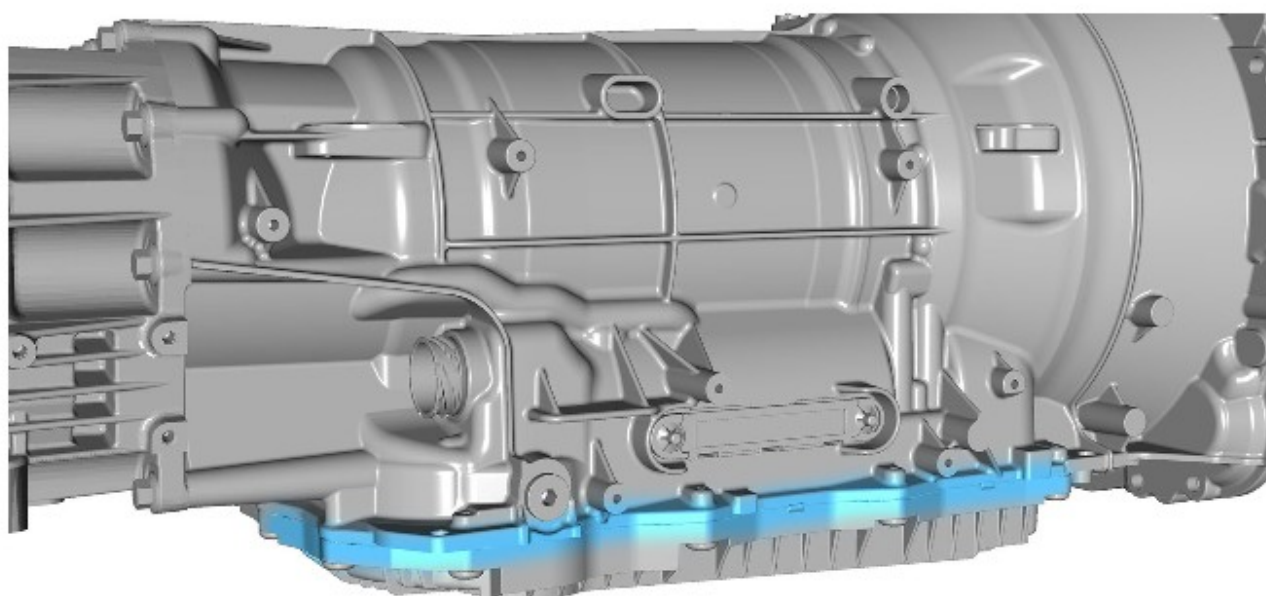
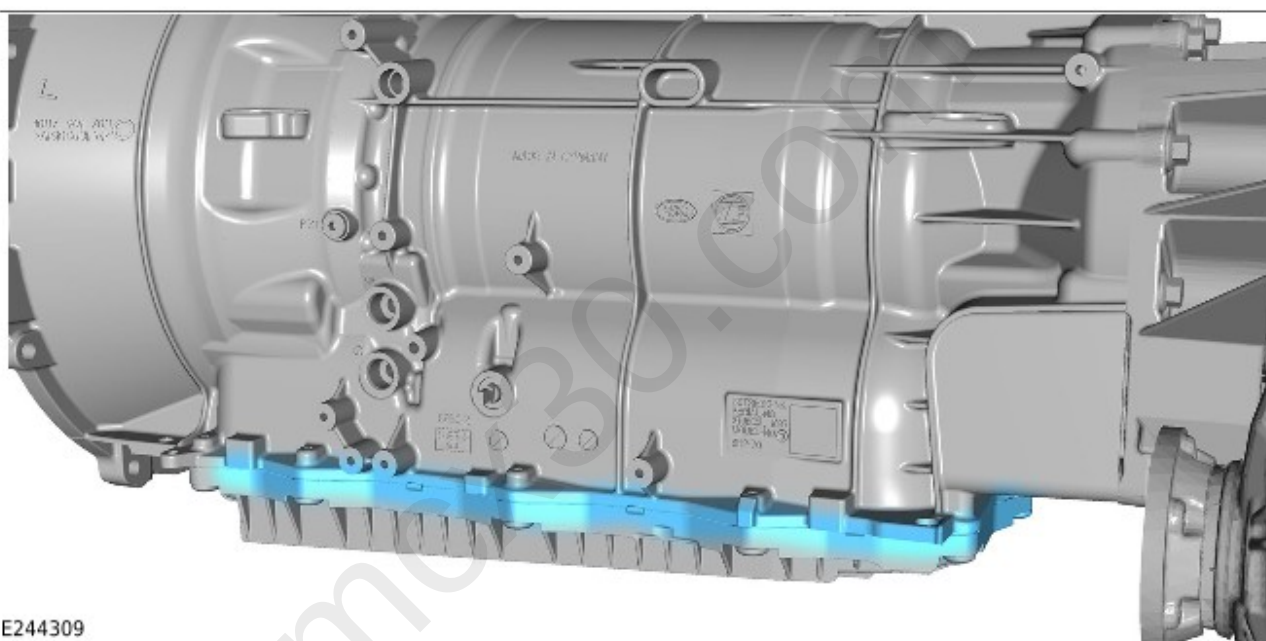
E244309

Due to capillary action, oil residue may be found in the joint between the transmission case and the oil pan. The potential leak path is shown in the illustration below.

3. Thoroughly coat the potential leak locations using a suitable leak detector spray, refer to the illustrations above.
4. Run the vehicle up to operating temperature, raise the ramp and use a suitable inspection lamp to identify the source of the transmission oil leak.
5. Identify the source of the oil leak and take clear, in focus pictures. These may be required to support your warranty claim.
6. Once the source of the leak has been identified, refer to the relevant technical bulletin or refer to the relevant section of the workshop manual and repair as necessary. If the source of the leak is not shown in the illustrations above, report using an Electronic Product Quality Report (EPQR). Make sure to attach clear, in focus pictures showing the use of leak detection spray and the exact position of the leak.

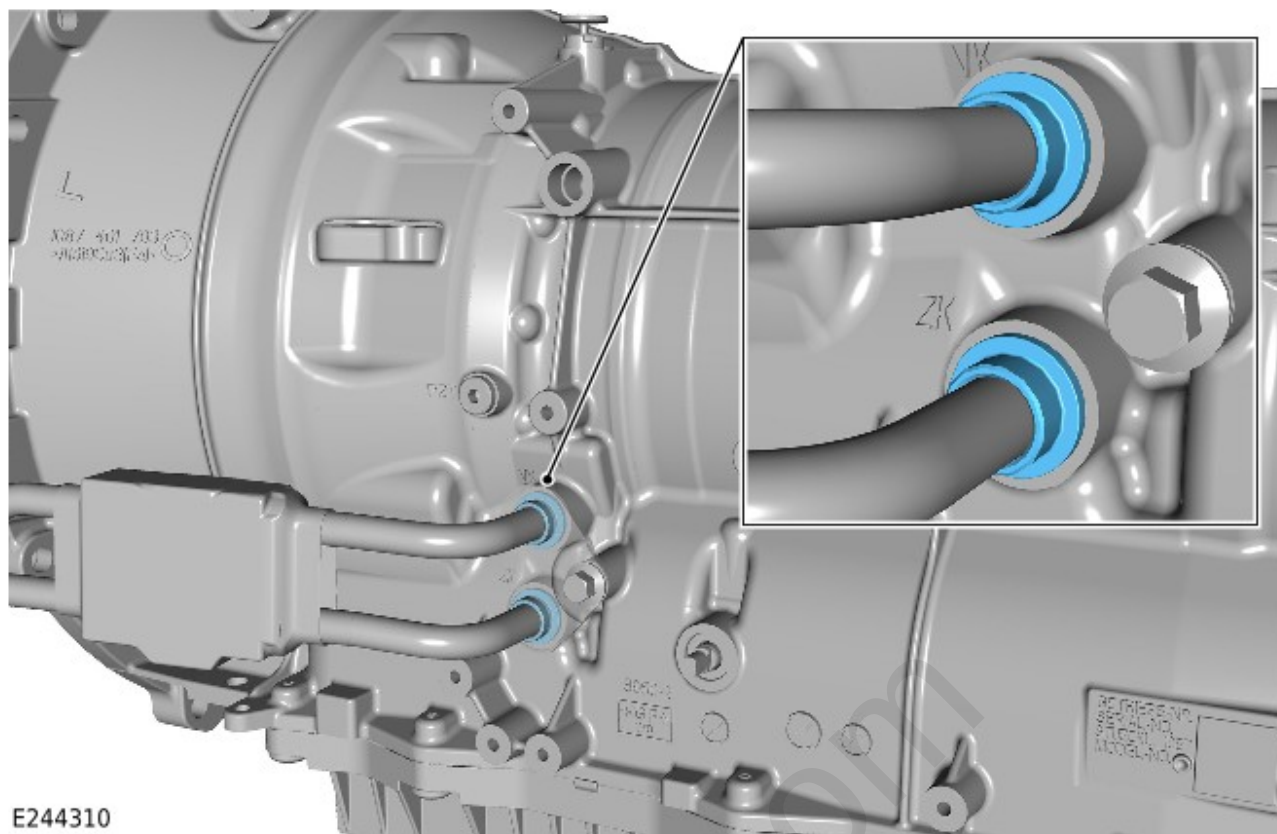
E244310

Other potential leak sources are the transmission oil cooler pipe unions. Visually inspect the areas shown in the illustration below.

The bracket securing the transmission oil pipes has been removed to provide extra clarity.

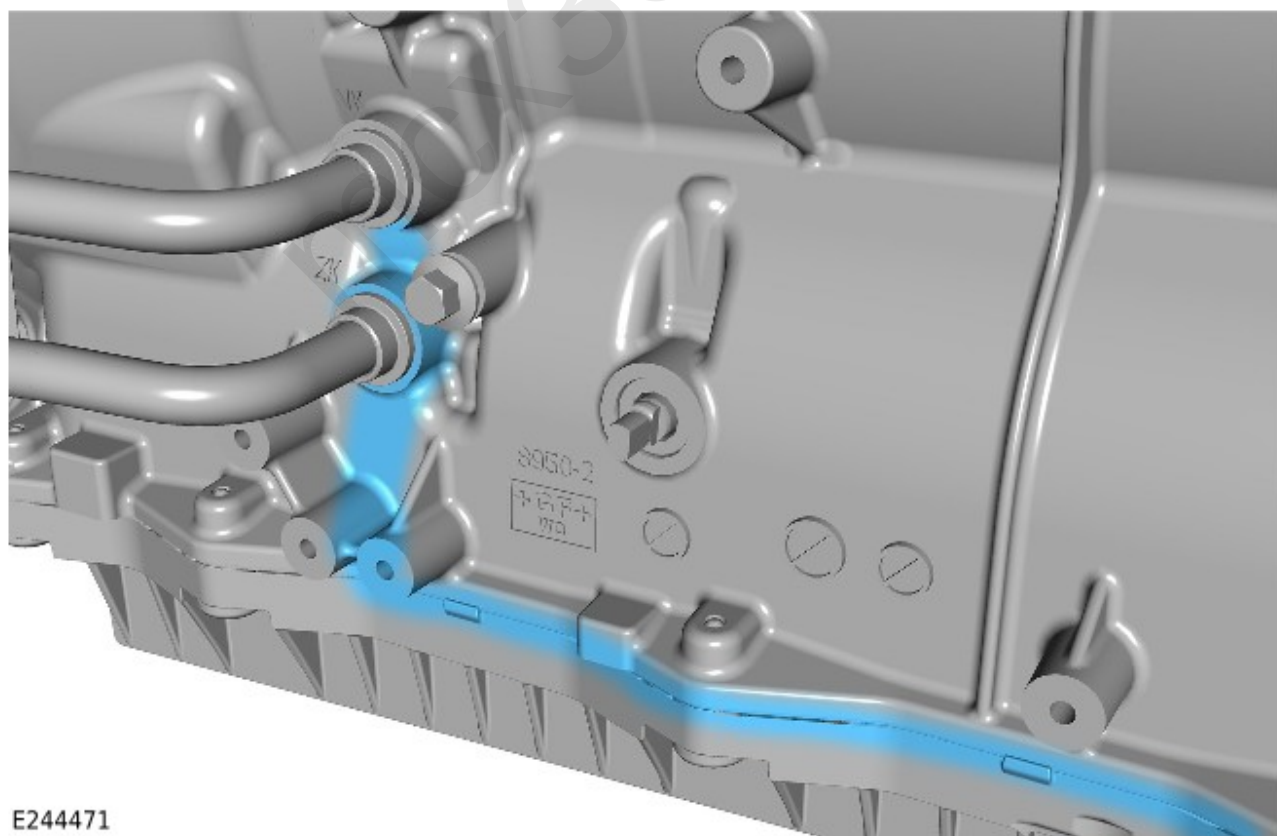
E244471

The potential leak path is shown in the illustration below.
