| <b>Title:</b> AE80F AUTOMATIC TRANSMISSION / TRANSAXLE: ATF TEMPERATURE SENSOR: REMOVAL; 2016 - 2018 MY LX570 [09/2015 - ] | | |

## REMOVAL

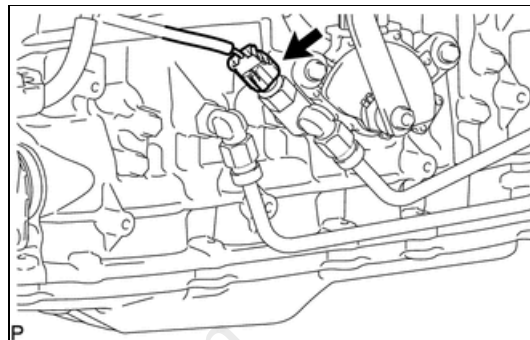
(a) Disconnect the temperature sensor connector.

(b) Using a 19 mm deep socket wrench, remove the temperature sensor.
