| <b>Title:</b> AE80F AUTOMATIC TRANSMISSION / TRANSAXLE: PARK / NEUTRAL POSITION SWITCH: ADJUSTMENT; 2016 - 2018 MY LX570 [09/2015 - ] | | |

## 1. ADJUST PARK/NEUTRAL POSITION SWITCH ASSEMBLY

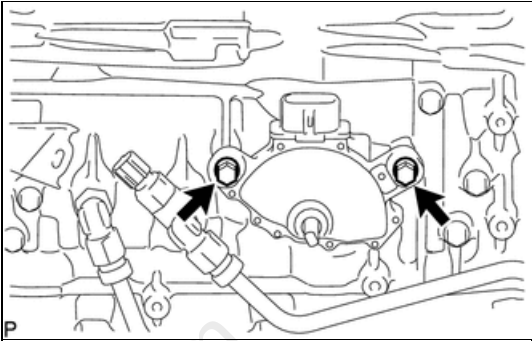
- (a) Loosen the 2 bolts of the park/neutral position switch assembly and move the shift lever to N.

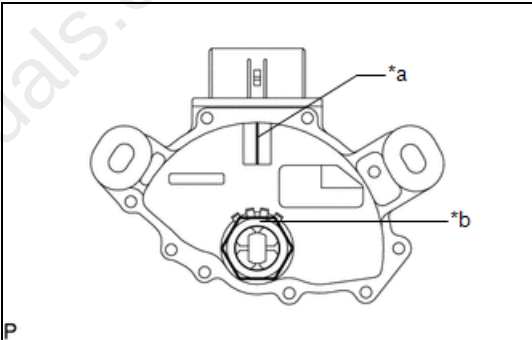
- (b) Align the groove with the neutral basic line.

| *a | Neutral Basic Line |
| *b | Groove |

- (c) Hold the switch in the position described above and tighten the 2 bolts.

5.4 N·m {55 kgf·cm, 48 in·lbf}
