| <b>Title:</b> AE80F AUTOMATIC TRANSMISSION / TRANSAXLE: SPEED SENSOR(for Output Revolution Sensor): REMOVAL; 2016 - 2018 MY LX570 [09/2015 - ] | | |

#### 2. REMOVE TRANSMISSION REVOLUTION SENSOR (SP2)

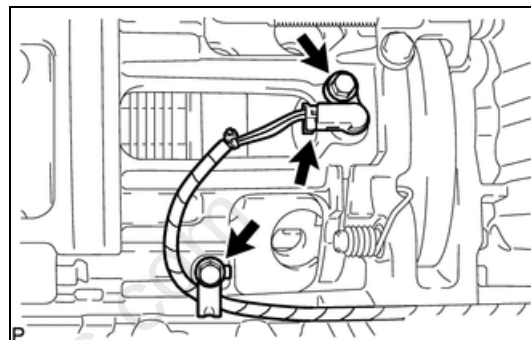
(a) Remove the bolt and wire harness clamp.

(b) Disconnect the connector from the transmission revolution sensor (SP2).

(c) Remove the bolt and transmission revolution sensor (SP2) from the automatic transmission case sub-assembly.
