| <b>Title:</b> AE80F AUTOMATIC TRANSMISSION / TRANSAXLE: TRANSMISSION WIRE: INSPECTION; 2016 - 2018 MY LX570 [09/2015 - ] | | |

1. INSPECT TRANSMISSION WIRE (ATF TEMPERATURE SENSOR)

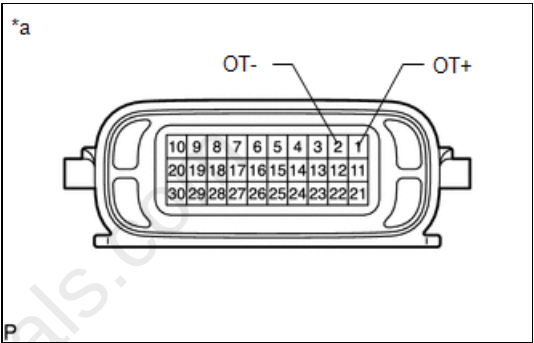
(a) Measure the resistance according to the value(s) in the table below.

| TESTER CONNECTION | ATF TEMPERATURE | SPECIFIED CONDITION |
|---|---|---|
| 1 (OT+) - Body ground | Always | 10 kΩ or higher |
| 2 (OT-) - Body ground | Always | 10 kΩ or higher |

| *a | Component without harness connected<br>(Transmission Wire (ATF Temperature Sensor)) |

| TESTER CONNECTION | ATF TEMPERATURE | SPECIFIED CONDITION |
|---|---|---|
| 1 (OT+) - 2 (OT-) | 10°C (50°F) | 6.445 kΩ |
| | 25°C (77°F) | 3.5 kΩ |
| | 110°C (230°F) | 0.247 kΩ |

If the result is not as specified, replace the transmission wire (ATF temperature sensor).
