| <b>Title:</b> AXLE AND DIFFERENTIAL: FRONT AXLE HUB: REASSEMBLY; 2016 - 2018 MY LX570 [09/2015 - ] | | |

## REASSEMBLY

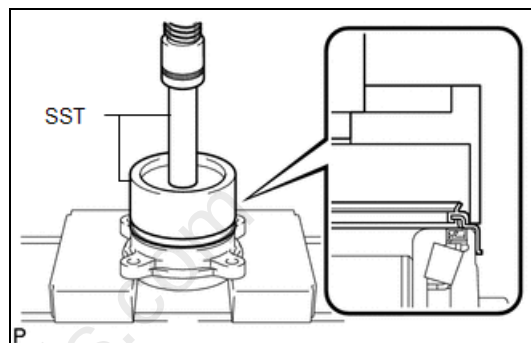
### 1. INSTALL FRONT AXLE HUB OIL SEAL

(a) Using SST and a press, press in a new oil seal.

**SST: 09608-36010**

**SST: 09950-70010**

09951-07100

Do not damage the oil seal.

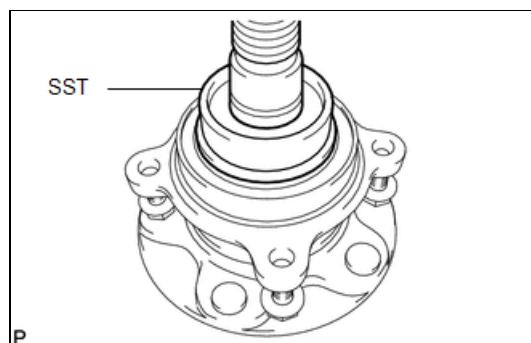
### 2. INSTALL FRONT AXLE WITH ABS ROTOR BEARING ASSEMBLY

(a) Using SST and a press, press in a new bearing.

**SST: 09608-32010**

- Insert 4 bolts into the bearing before installing the axle hub.
- Make sure to securely fit the bearing to the axle hub.
