| <b>Title:</b> DRIVE SHAFT / PROPELLER SHAFT: FRONT DRIVE SHAFT ASSEMBLY: REMOVAL; 2016 - 2018 MY LX570 [09/2015 - ] | | |

## REMOVAL

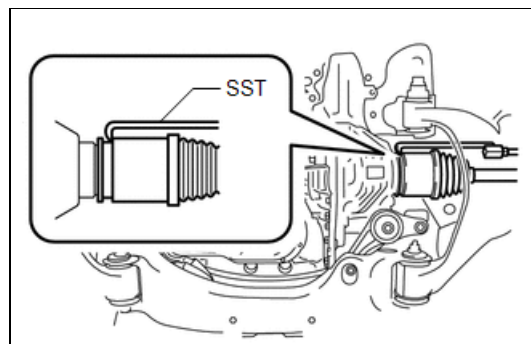
- (a) Using SST, remove the drive shaft.

**SST: 09520-01010**

**SST: 09520-24010**

09520-32040

- Be careful not to damage the dust cover and oil seal.
- Move the drive shaft while keeping it level.
