| <b>Title:</b> DRIVE SHAFT / PROPELLER SHAFT: FRONT PROPELLER SHAFT ASSEMBLY: DISASSEMBLY; 2016 - 2018 MY LX570 [09/2015 - ] | | |

## DISASSEMBLY

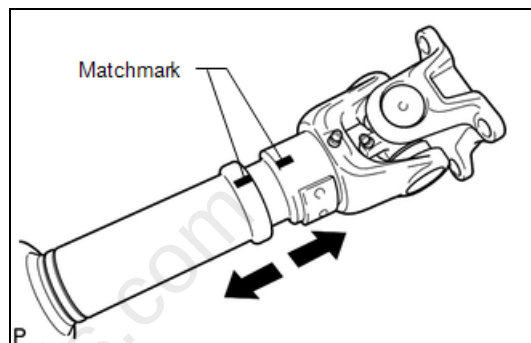
- (a) Place matchmarks on the propeller shaft and sleeve yoke.

- (b) Disconnect the sleeve yoke from the propeller shaft.  
(c) Clean off any grease on the spline.

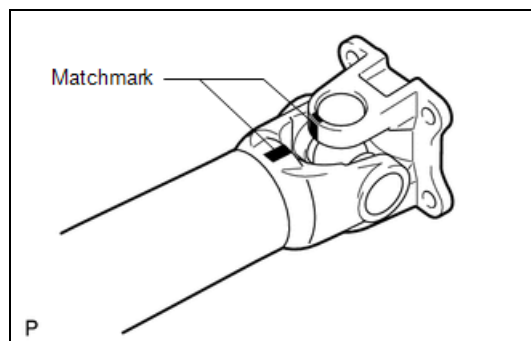
- (a) Place matchmarks on the flange yoke and sleeve yoke or propeller shaft.

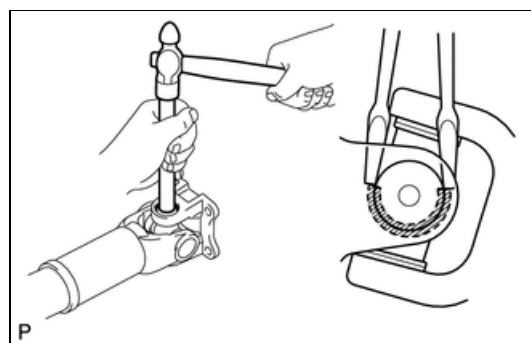
- (b) Using a brass bar and hammer, slightly tap in the spider bearing outer races.

- (c) Using 2 screwdrivers, remove the 4 snap rings from the grooves.

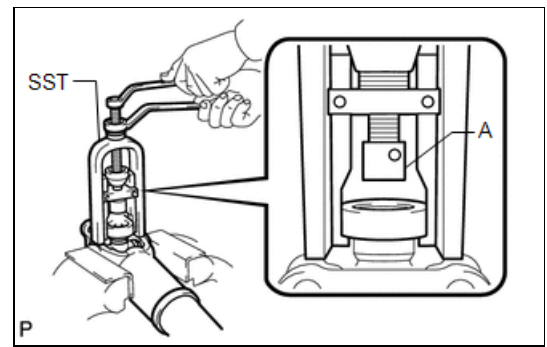
(d) Using SST, push out the bearing from the flange.

**SST: 09332-25010**

Before installing SST, sufficiently raise the part labeled A. If part A is too low, SST may be difficult to install.

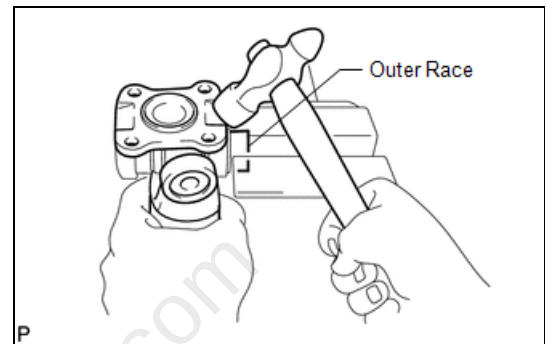
(e) Clamp the bearing outer race in a vise and tap off the flange with a hammer.

Remove the bearing on the opposite side using the same procedure.

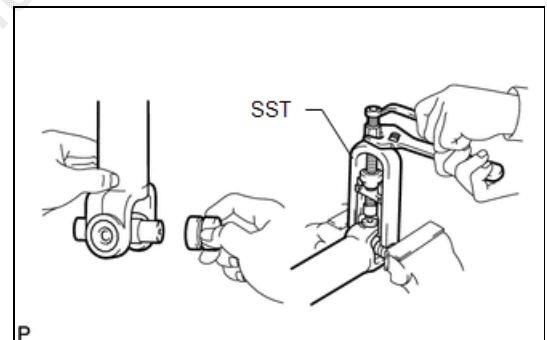
(g) Install the 2 removed bearing outer races to the spider.

(h) Using SST, push out the bearing from the yoke.
