| <b>Title:</b> DRIVE SHAFT / PROPELLER SHAFT: PROPELLER SHAFT ASSEMBLY: REMOVAL; 2016 - 2018 MY LX570 [09/2015 - ] | | |

## REMOVAL

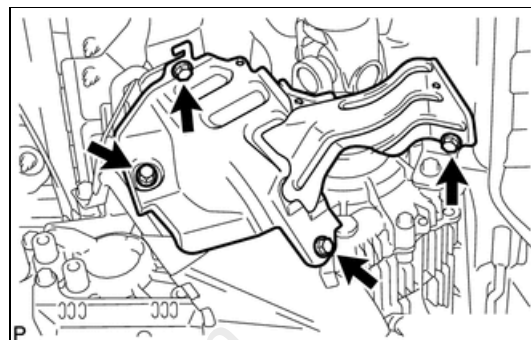
#### 1. REMOVE TRANSFER HEAT INSULATOR

- (a) Remove the 4 bolts and insulator.

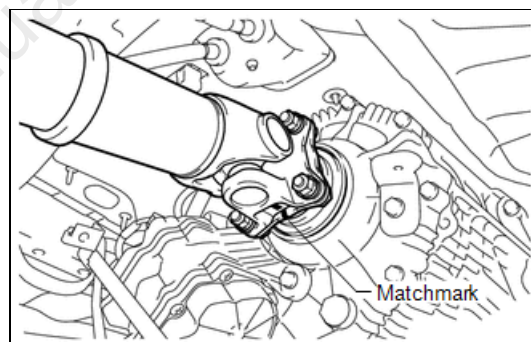
- (a) for Transfer Side:

- (1) Place matchmarks on the propeller shaft flange and transfer flange.

- (2) Remove the 4 nuts and 4 washers.

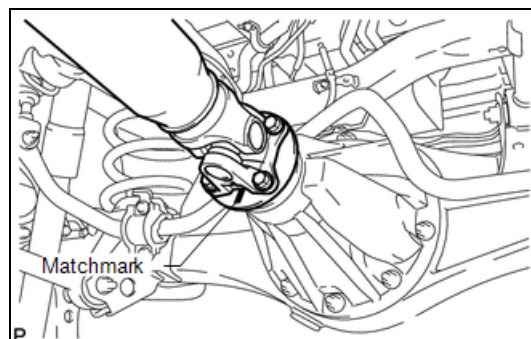
- (b) for Differential Side:

- (1) Place matchmarks on the propeller shaft flange and rear differential flange.

- (2) Remove the 4 nuts, 4 bolts and 4 washers.
