| <b>Title:</b> JF2A TRANSFER / 4WD / AWD: TRANSFER CASE FRONT OIL SEAL: REPLACEMENT; 2016 - 2018 MY LX570 [09/2015 - ] | | |

## REPLACEMENT

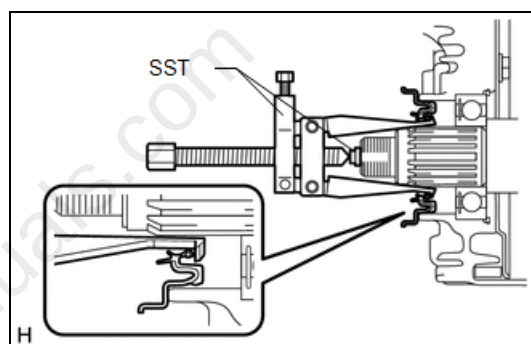
#### 4. REMOVE FRONT TRANSFER CASE OIL SEAL

(a) Using SST, remove the front transfer case oil seal.

**SST: 09308-10010**

**SST: 09950-40011**

09957-04010

- Be careful not to damage the front transfer case oil seal and front transfer case contact surface.
- Apply grease to the tip of SST center bolt before use.

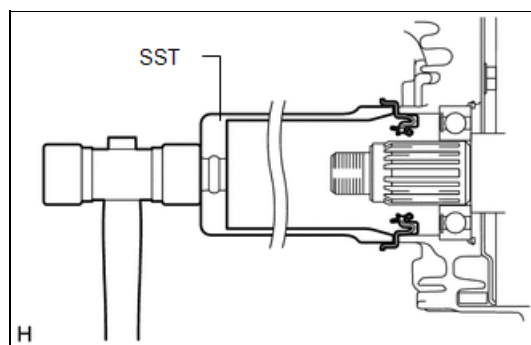
#### 5. INSTALL FRONT TRANSFER CASE OIL SEAL

(a) Apply transfer oil to the spline of the driven sprocket.

(b) Using SST and a hammer, tap in a new front transfer case oil seal.

**SST: 09613-26010**

The front transfer case oil seal should be installed completely.
